Manhole Inspection Summary

Manhole # S17K__044MH

Location Address: **FREDERICK AV** Cross Street: **S WARWICK AV**

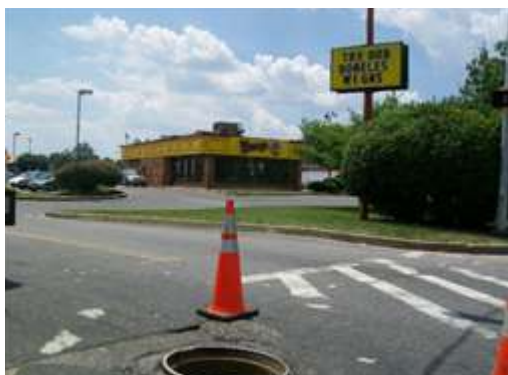
Defect 4

asphalt missing to the point that rim is above grade by about 1"

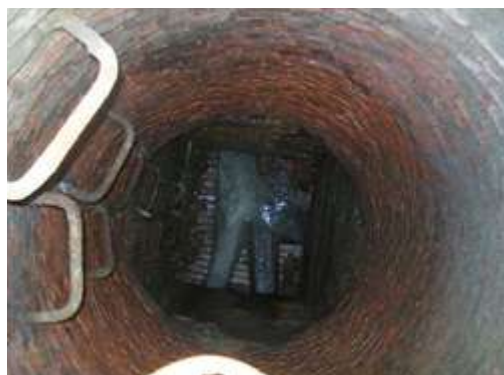
Defect 3

Steps Count: **12** Missing: **1** ☒ Corroded

missing step

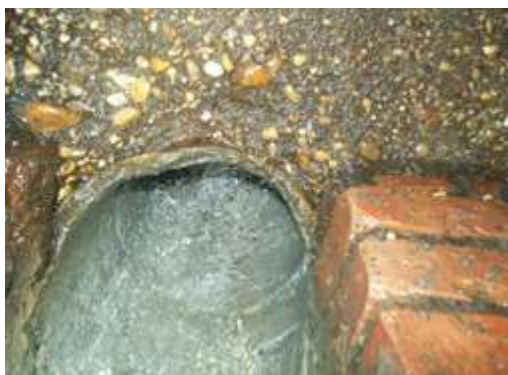
Defect 2

Condition: ☐ Sound ☐ Cracked ☐ Root Intrusion ☐ Loose Brick ☒ Deteriorated

DETERIORATED CONCRETE BARRELL

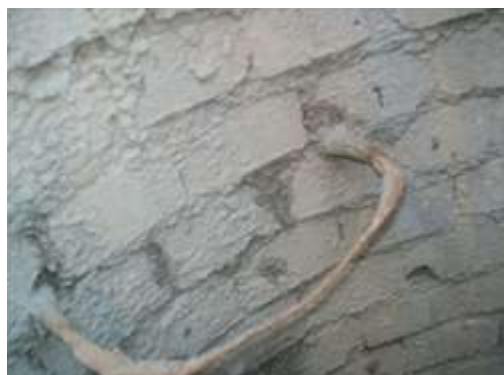
Defect 1

Infiltration: ☐ None ☐ Joint ☐ Cracks ☐ Mortar ☐ Roots ☒ Wall

CORRODED STEPS; EVIDENCE OF INFILTRATION FROM CORBEL WALL
